# **Investigation Report No. u1922**

concerning the accident

to the aircraft Piper PA-46-350P JetProp, D-EMDB

on 7 April 2004

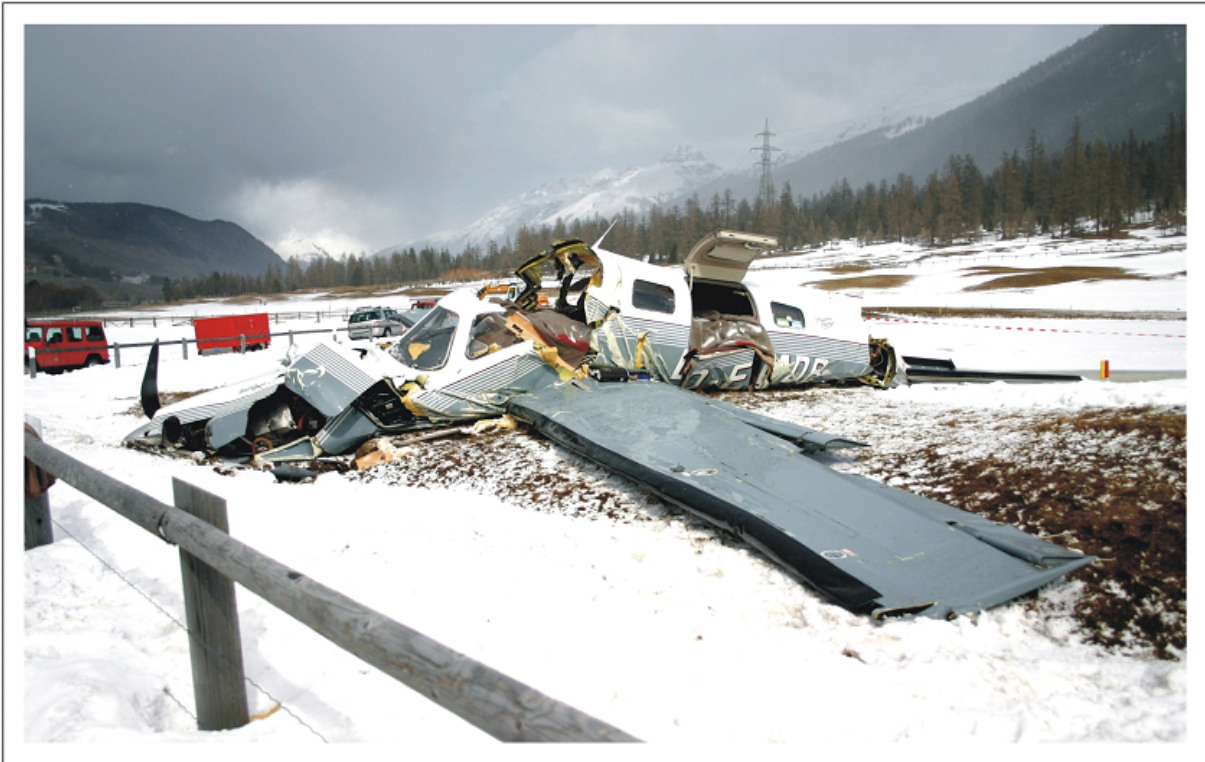
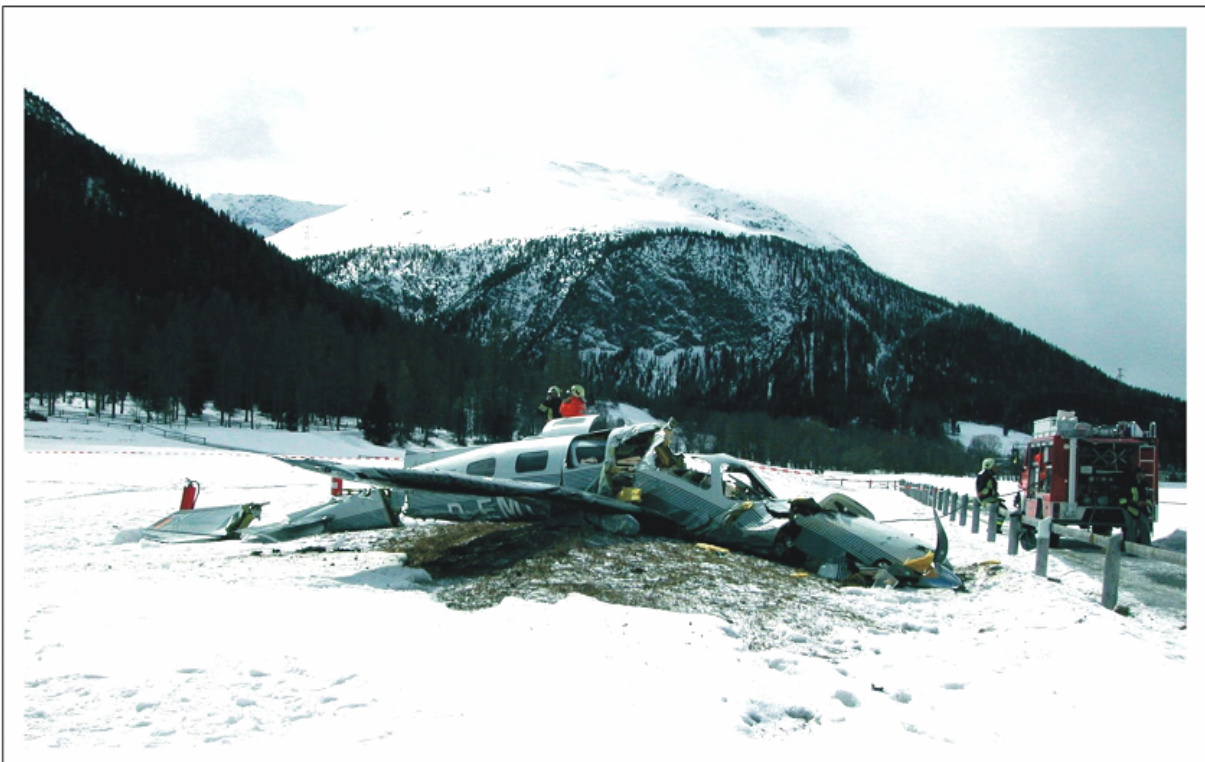
Annexe 1: Overview of the site of the accident

The aircraft came down in a grassed area within the golf course, only a few metres from a minor road (see Annex 4.1).

The aircraft hit the ground in a practically horizontal attitude and remained on the spot. The traces on the ground did not indicate any forward motion at all. The fuselage broke into three main sections on impact. The wings were deformed but still attached to the central section of the fuselage.

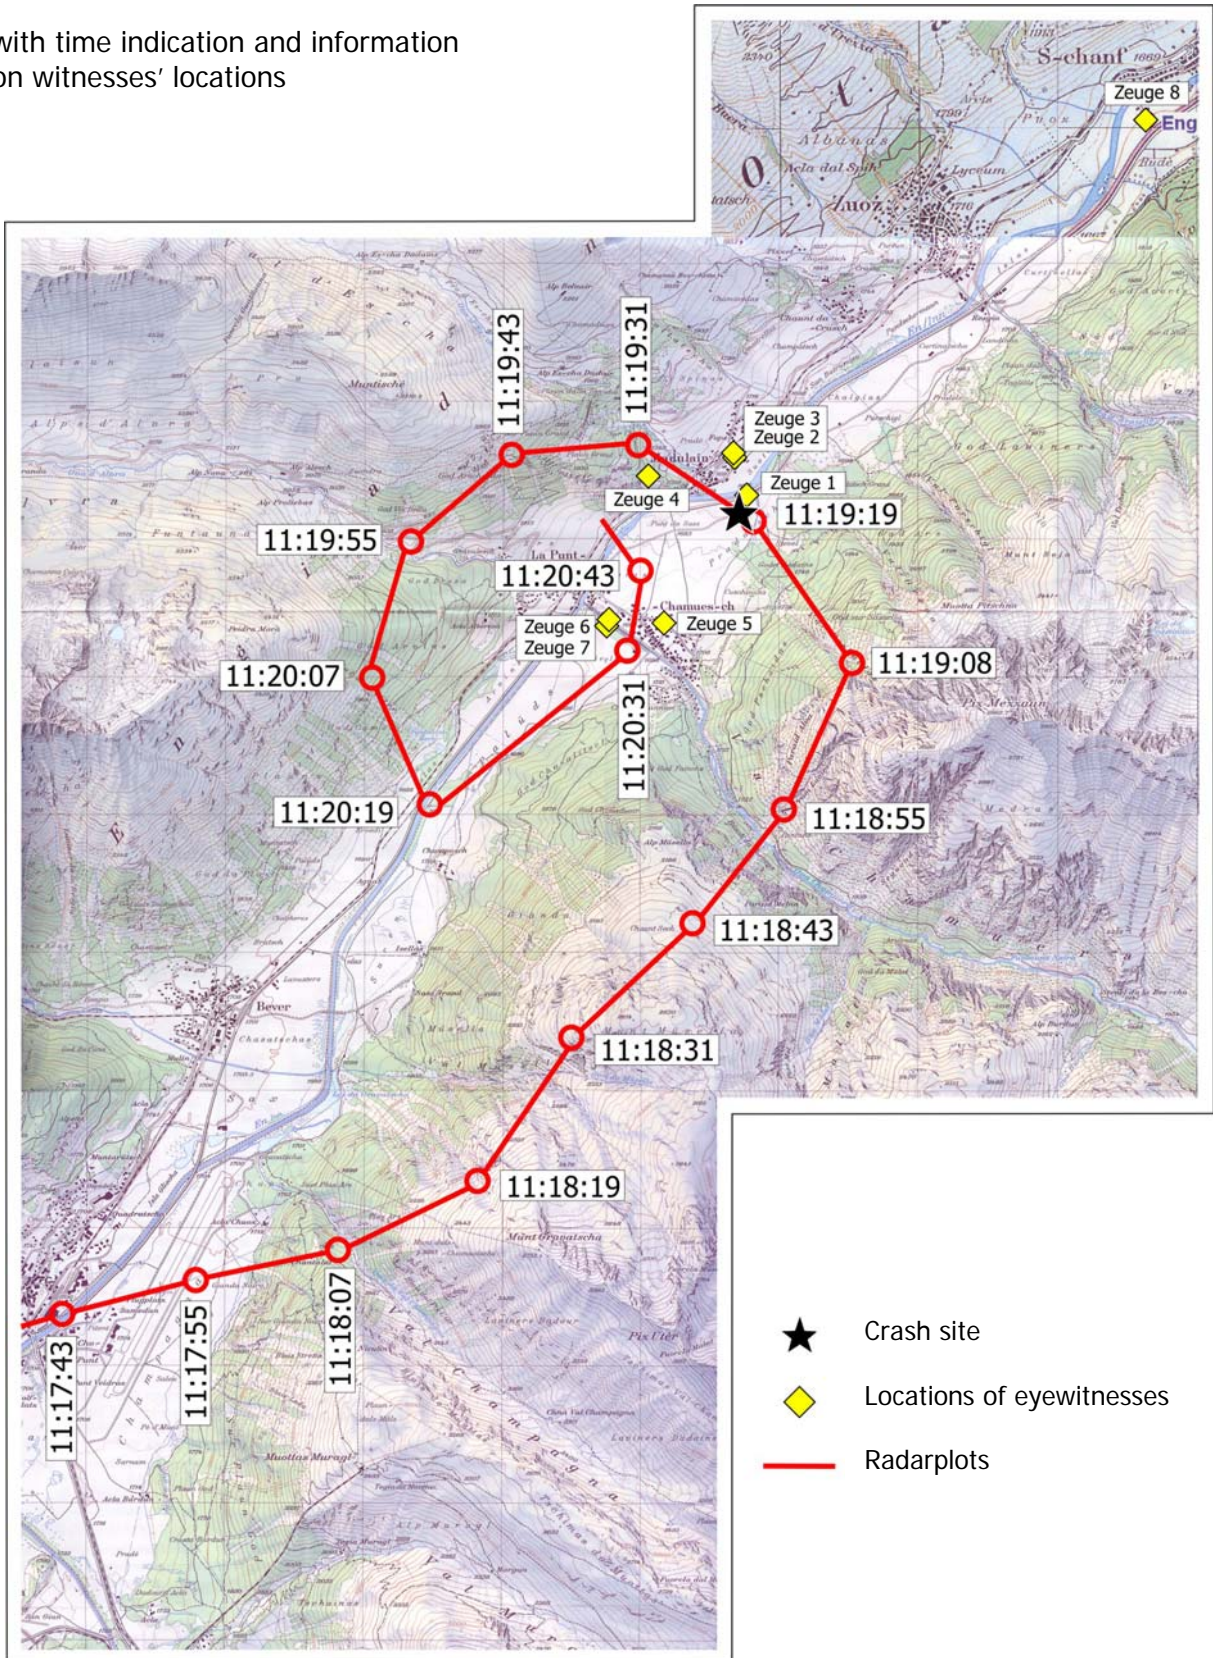
Annexe 2: Radar track on a geographical map

Radar track superimposed on a geographical map

with time indication and information on witnesses' locations

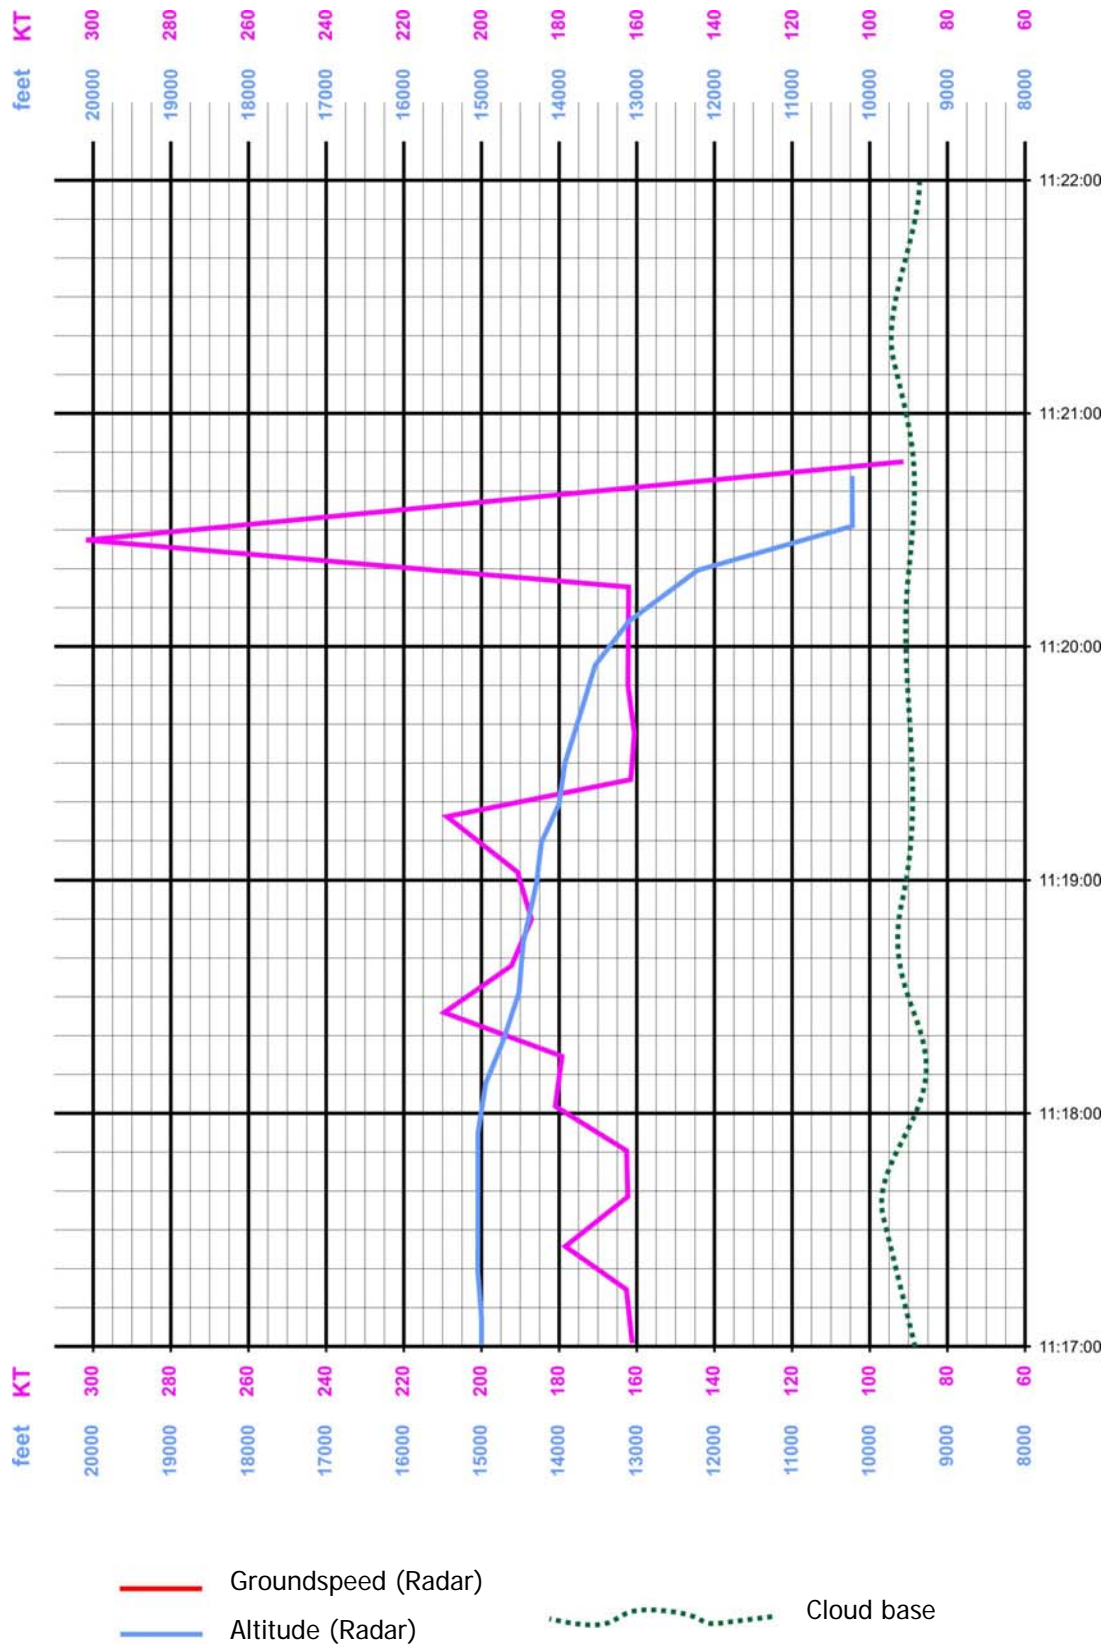
### Annexe 3: Graphic representation of speed and height

The data from the "Shadin Engine Trend Monitoring System" showed that during this manoeuvre the aircraft had reached an excessively high speed. Shortly afterwards, at less than 60 KIAS, a power was set which was above the maximum permissible value.

Information on the last five minutes according to radar recordings
